NBSIR 76-1132

Personnel Guardrails for the Prevention of Occupational Accidents

Final Report

Prepared for
Occupational Safety and Health Administration
Department of Labor
Washington, D. C. 20210

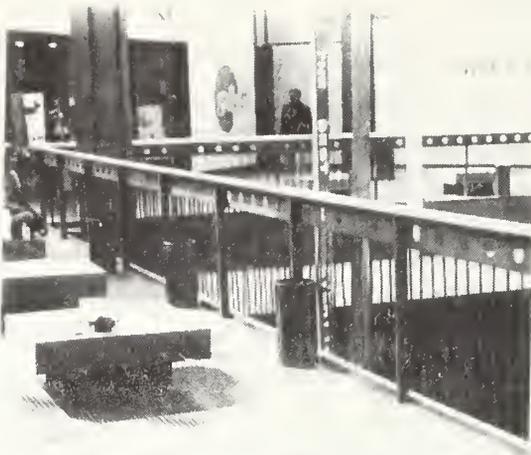
Figure 4.1 Guardrail location within enclosed shopping center.

The first guardrail installation examined was located on the second level of an enclosed shopping center. The area was an elevated walkway which provided access to a variety of retail stores. The guardrail functioned as a barrier restricting movement or accidental falls into a series of large wells opening to the ground level (figure 4.1).

The top rail was made of aluminum tubing material and was located 41.75 in (106 cm) above the tread. The steel posts of tubular section were spaced at 5 ft (152.4 cm) on centers and the tubular steel toeboard was approximately 2 in (5.08 cm) high. There were no intermediate rails but rather 0.5-in (1.27cm) round steel balusters placed 5 in (12.7 cm) on centers. As indicated in figure 4.1, several of these bannisters were bent out of shape creating a potentially hazardous situation for accidental passage of children through guardrail openings. However, consideration of such a concern is not within the scope of these studies which are addressed to the guardrail needs of adult personnel.

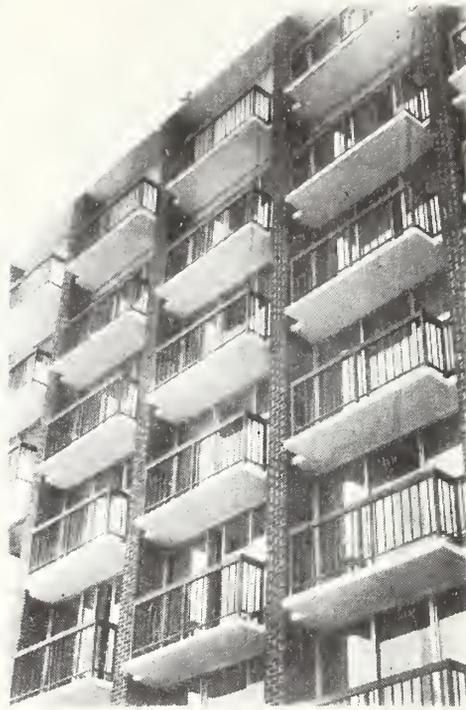
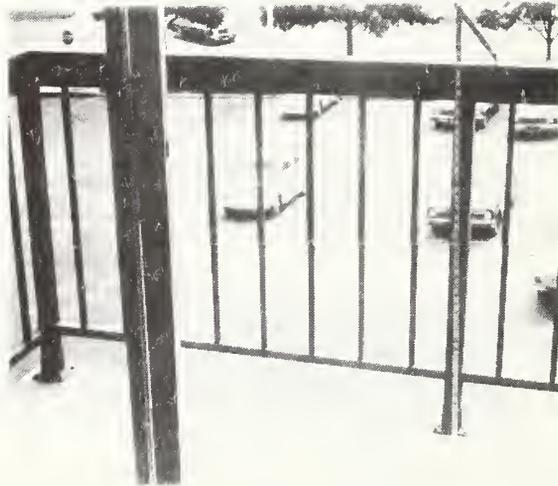
Figure 4.6 Permanent guardrail installations on balconies of multi-story hotel structure.

The first guardrail installation examined was located at the edges of the balconies of the guest rooms of a hotel. The guardrail served as a barrier to prevent falls from heights of one to six stories above grade (figure 4.6).

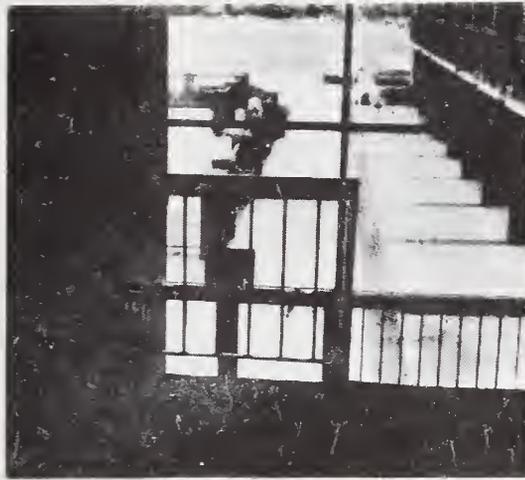
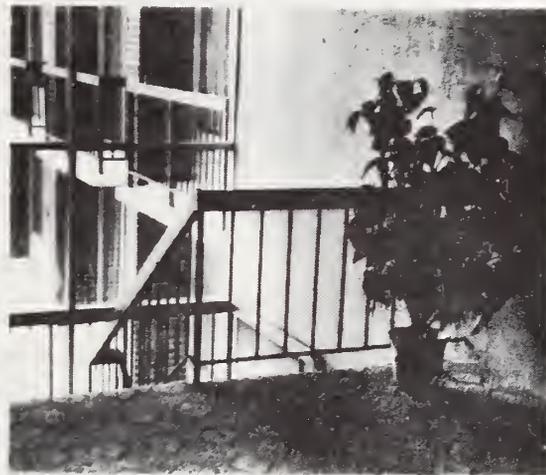
Figure 4.7 Permanent guardrails used in lobby of hotel structure.

The second guardrail installation examined was located within the lobby of the same building. The lobby served as an access to various hotel service areas and as a sitting lounge. On each side of an open stairway, a guardrail served as a barrier to prevent falls to the ground level one story below (figure 4.7).

The light level was high because of a nearby window wall. In addition, the window wall produced a significant amount of reflected glare in the location adjacent to the guardrail.

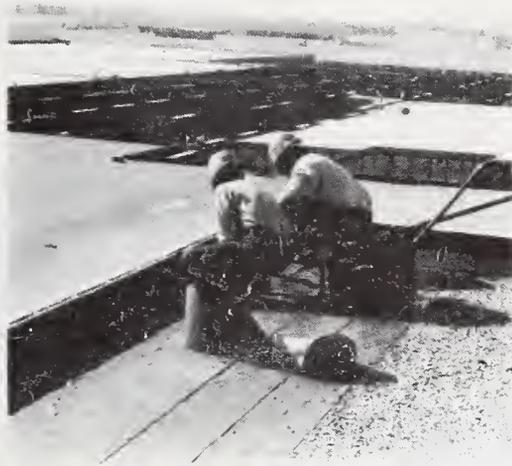
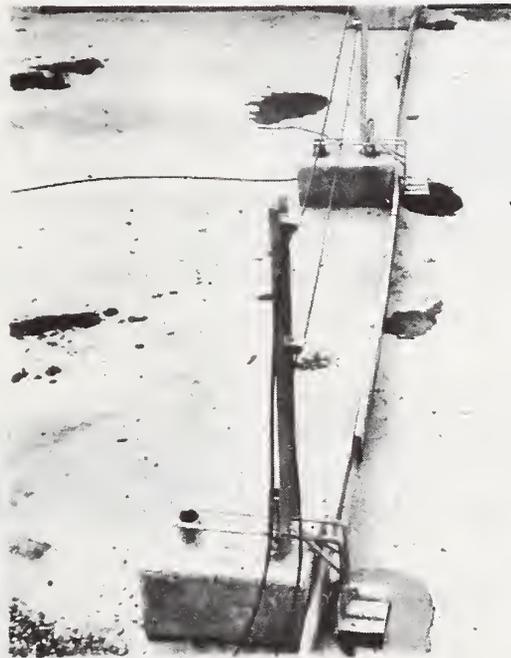
Figure 4.12 Additional exhibits of built-up roofing operations.

The symbolic guardrail consisted of two 1/4-in (0.64-cm) wire ropes clamped to steel posts attached to 40-lb (178-N) cast concrete blocks at the base. Trials were being made to increase the lateral stability of the posts through adhesion of stick clips with the tar surface (figure 4.12 b). Without such adhesion, a 6 lb. (26.7N) horizontal force applied to the top of the post would cause it to overturn.

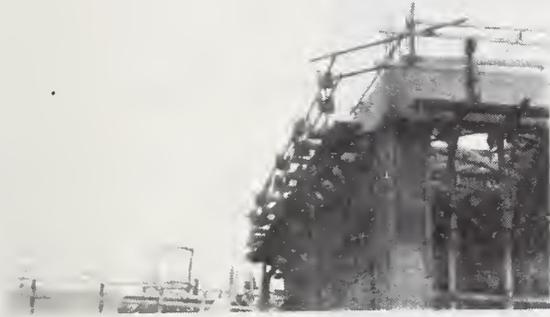
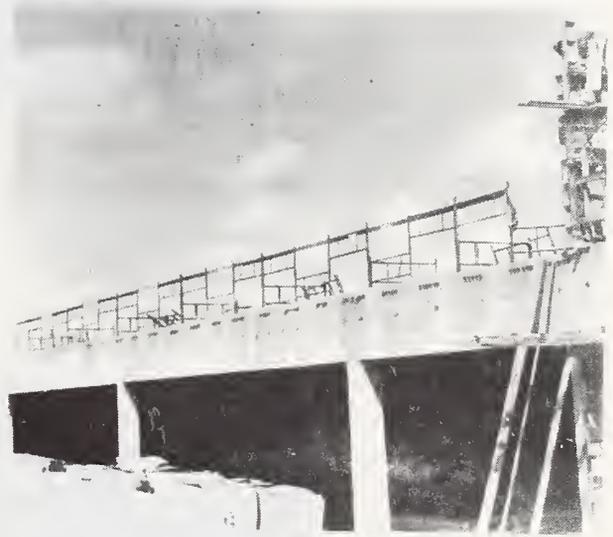
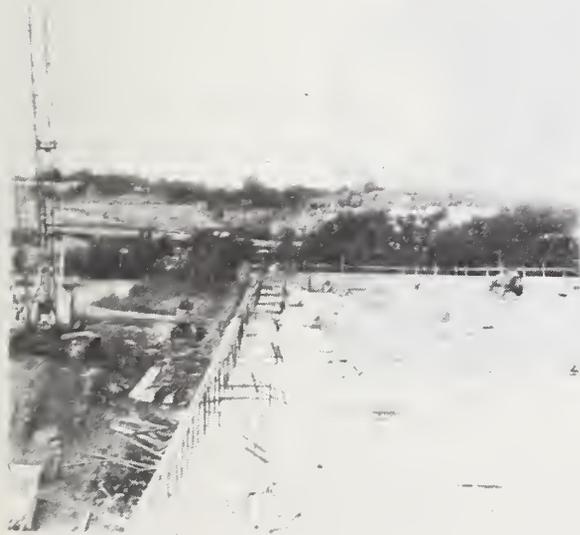
Figure 4.13 Miscellaneous types of temporary guardrails used in cast-in-place concrete building construction.

At the second site visited (figure 4.13 b and c), the concrete had already been cast and the forms removed. The guardrails were placed at the edge of the concrete slabs to prevent accidental falls of workers engaged in concrete curing and finishing operations. The guardrails consisted of modular steel pipe framing units joined together by a wood top rail. The assembly was seated on the concrete slab but not attached to it.

The lighting around the guardrail area was generally dim. As a result, the cable rails and sometimes the wood rails as well, tended to merge with the background and were not always readily visible. Another hazardous situation was the presence of miscellaneous construction materials and debris on the concrete floor adjacent to the rails.

There were two types of guardrails installed around the opening. One was constructed of wood (figure 14.a) with a 42-in (106.7-cm) high top rail and 24-in (61-cm) high intermediate rail. The spacing of the vertical posts varied from 5 ft to 7 ft (1.5 m to 2.1 m) on centers and the toeboard height varied from 4 in to 10 in (10.16 cm to 25.4 cm). The wood members were typically 2 in by 4 in (5.08 cm by 10.16 cm), nominal, and were fastened together with nails. The second type (figure 14.b) used 1/2-in (1.27-cm) wire rope top and intermediate rails, 43 in (109.2 cm) and 22 in (55.8 cm) from the tread, respectively. The vertical wood supports were spaced between 5 ft to 7 ft (1.5 to 2.1 m) on centers. The wood toeboard was 6 in (15.2 cm) high. The wire ropes were looped around and tied to concrete columns located along the periphery of the openings. They were kept taut by means of turnbuckles.

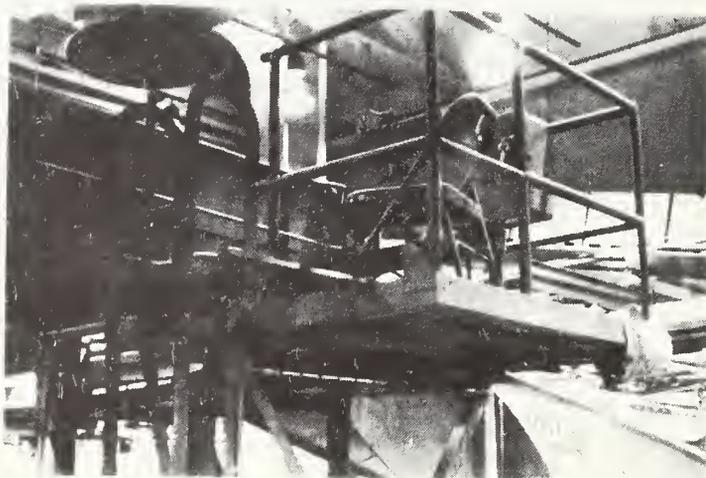
Figure 4.16 Guardrails installed around platform used for maintenance of machinery.

The guardrails examined were located in the mail sorting and routing areas of a large post office. They were installed around platforms used for the maintenance of conveyor belts and other machinery (figure 4.16). The platforms were approximately 12 ft (3.66 m) high and the rails served as barriers to prevent falls (figure 4.16).
